**High Resolution Satellite Imagery Reveals
Petroamazonas Violated Environmental Impact Study
by Building Road into Yasuní National Park**

May 2014

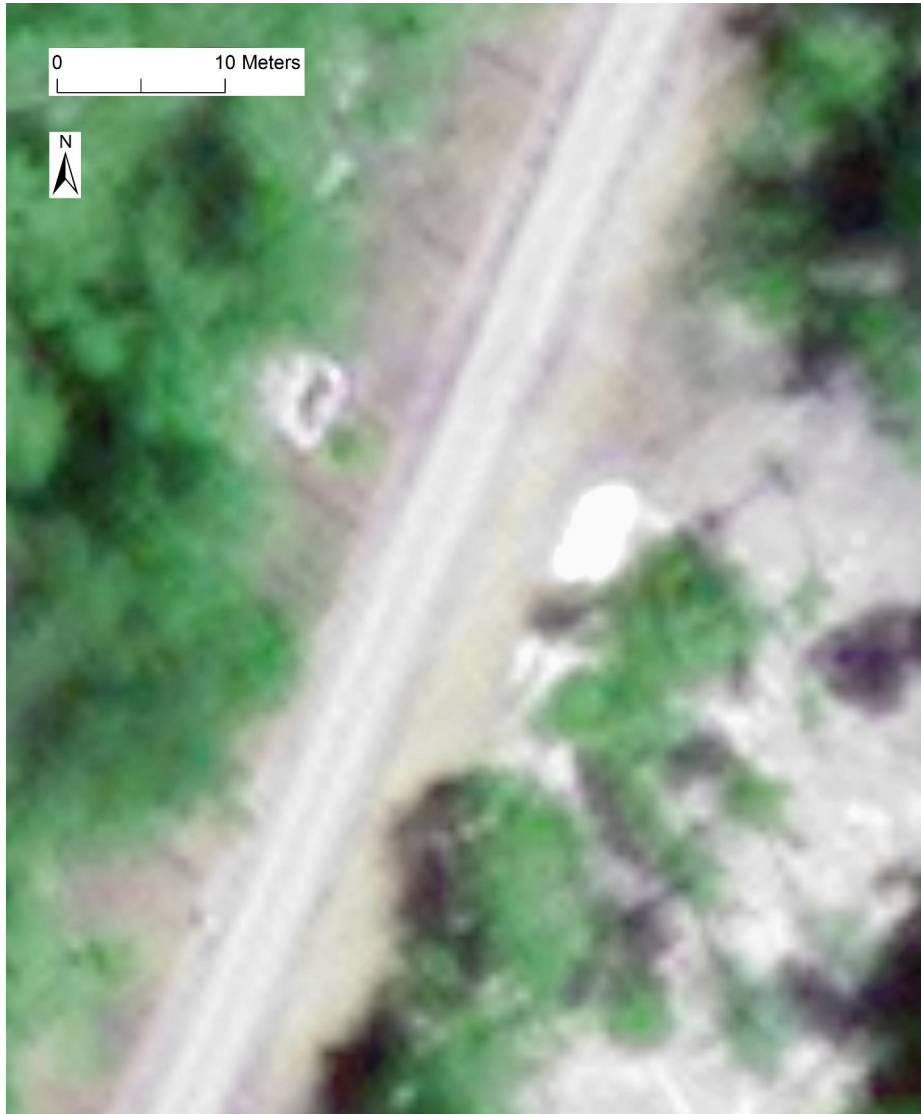
Figure 4. Route surface within Yasuní National Park.

The route surface within the park clearly appears to be drivable and road-like and not in an active state of closure (Figure 4). In fact, we documented at least 22 vehicles all along the route surface within the park (Figures 3, 5, 6, 7 and 8). We documented at least nine additional vehicles along the route outside of the park, including a large truck and traffic moving in both directions (Figures 9 and 10).

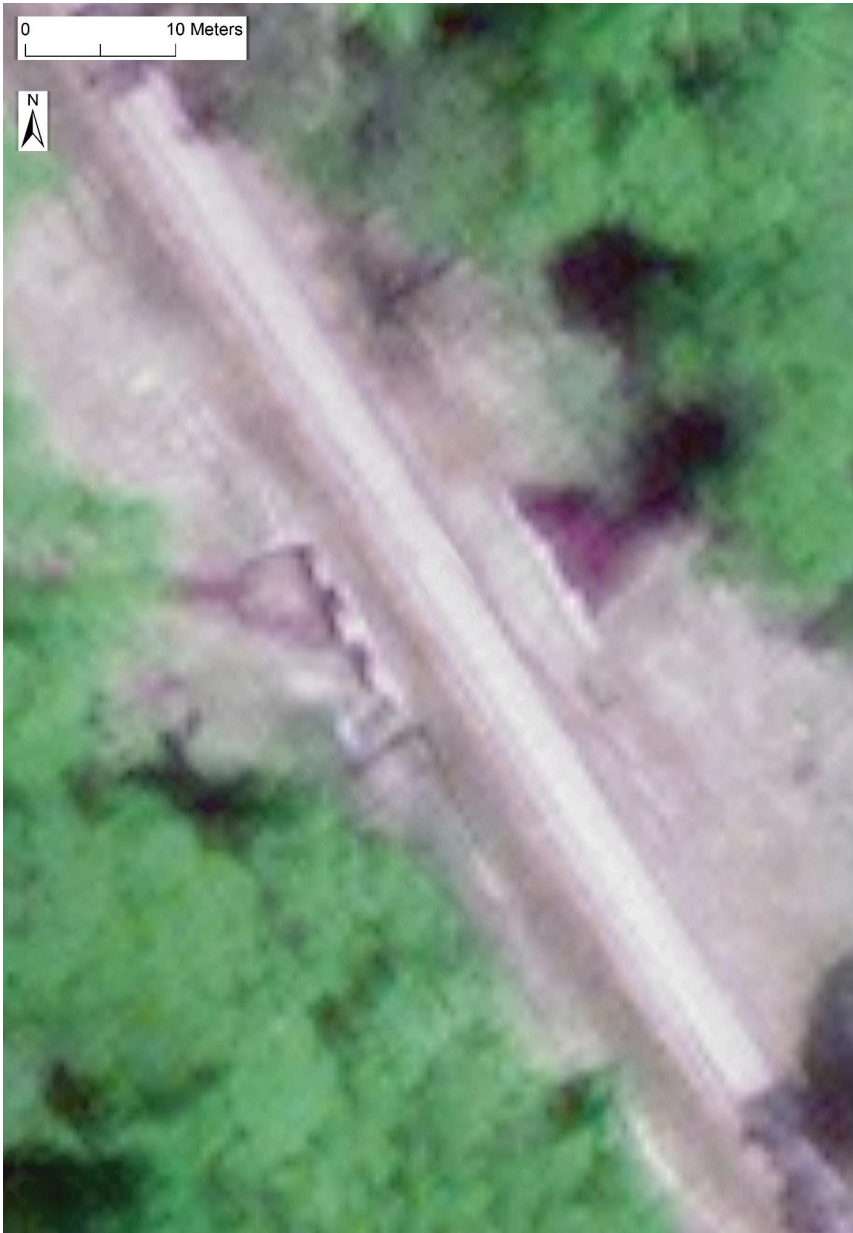
Figure 14. Example of a medium-sized culvert within the park.

In addition to the major bridge, there are 15 medium-sized (6 – 12 m) and 20 smaller (<5 m) waterway crossing structures within the park (Figure 14). For most of these structures (16 of 36), it is possible to see the water body in the image.

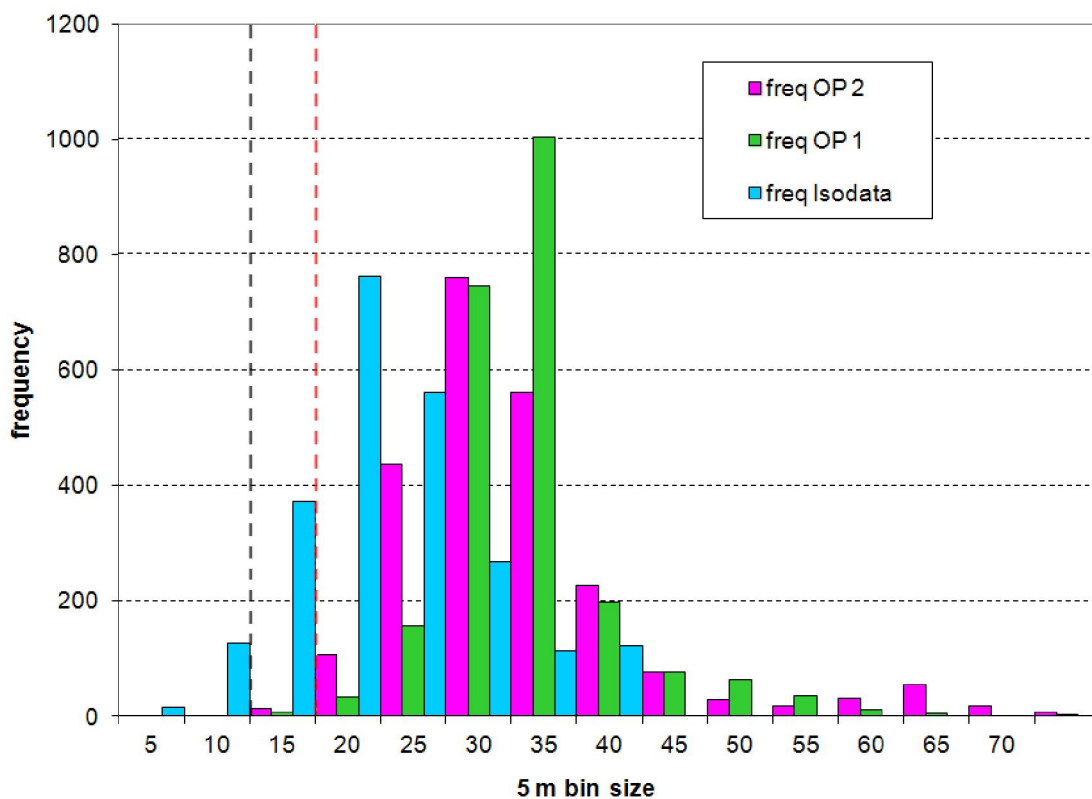
According to the supervised classification of two independent analysts, the access route from Rio Tiputini (boundary of Yasuní National Park) to the Apaika platform has an average ROW of 26 m (Analyst 1 = 25.9 m and Analyst 2 = 26.7 m). In other words, the average width of the flowline corridor within the park is 2.5 times greater than what was approved in the EIS, and more than 1.5 times greater than what is described in the EIS as destructive and not viable.

Frequency distribution of the ROW shows that less than 6% of the access route within the park complies with the EIS: 0.6% is ≤ 10 m and 5% is < 15 m. Thus, more than 94% of the route violates the parameters established in the EIS; 74% is between 20 and 30 m and 20% is between 30 and 68 m (Figure 15). The higher width values (30 - 68 m) are related to the geomorphological features of the Pindoyacu valley, characterized by wide flooded areas and swampland (Figure 16 and 17).

Figure 15. Frequency distribution of ROW from Rio Tiputini to Apaika drilling platform. The tail of histogram corresponds to the flooded ecosystems of the Pindoyacu valley crossing.
